Repair Project update-04- (at the Christmas Break)

The objective of the project is to conserve the archaeology in the northern works and to stabilise and consolidate the southern spillway.

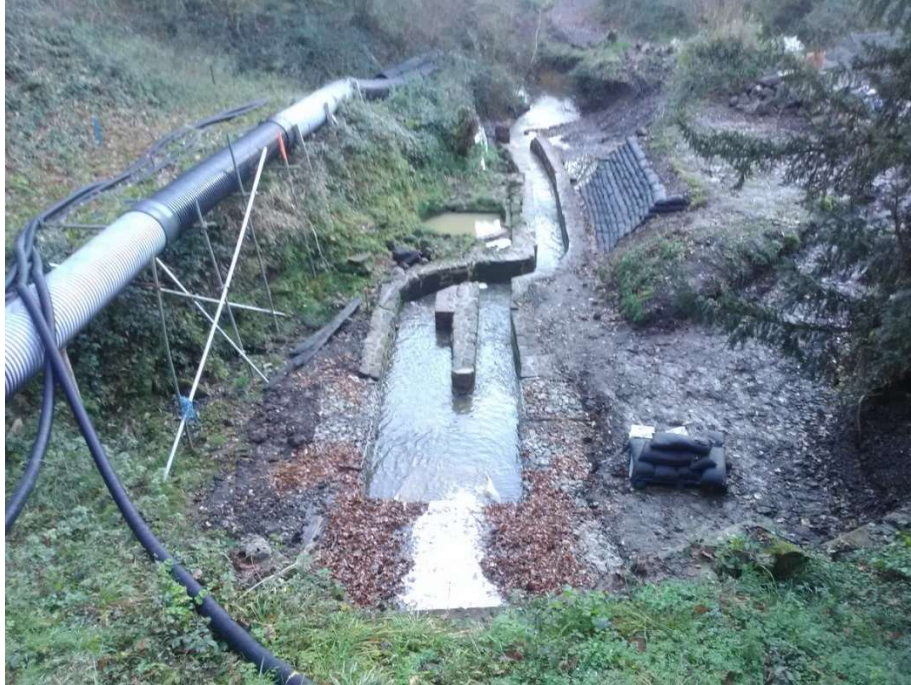
Little work is needed at the northern end except to complete the landscaping. As the budget is very restricted FFG have been asked to complete the landscaping which will begin as soon as C J Thorne have completed the contract and vacated the site. The work will involve setting out the soil filled sandbags and back filling with slag where necessary. We will need volunteers please!!!

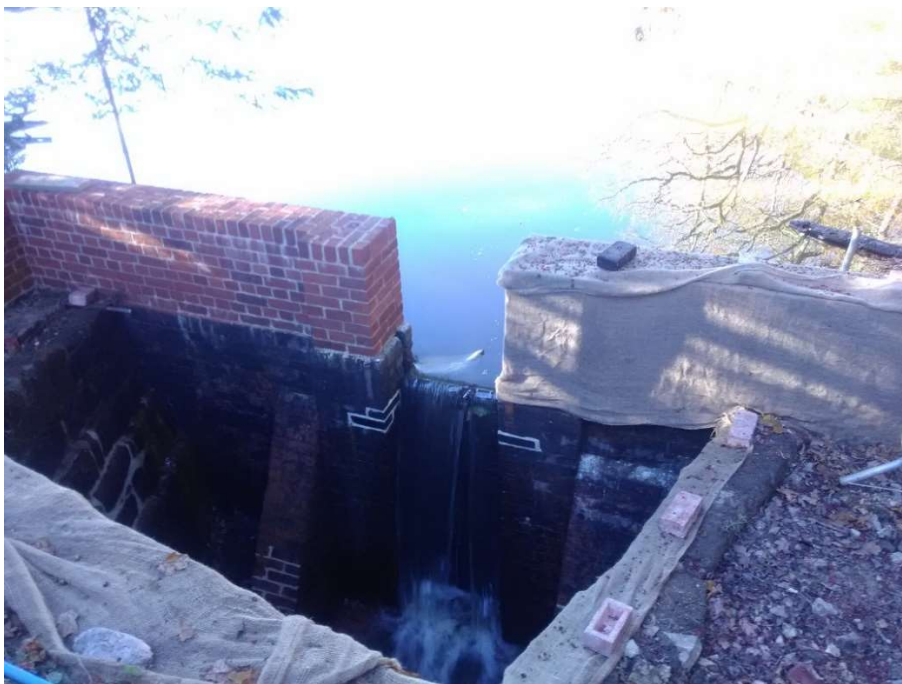
Again little work is needed here until the new penstocks and trash screens arrive which will be any day now.

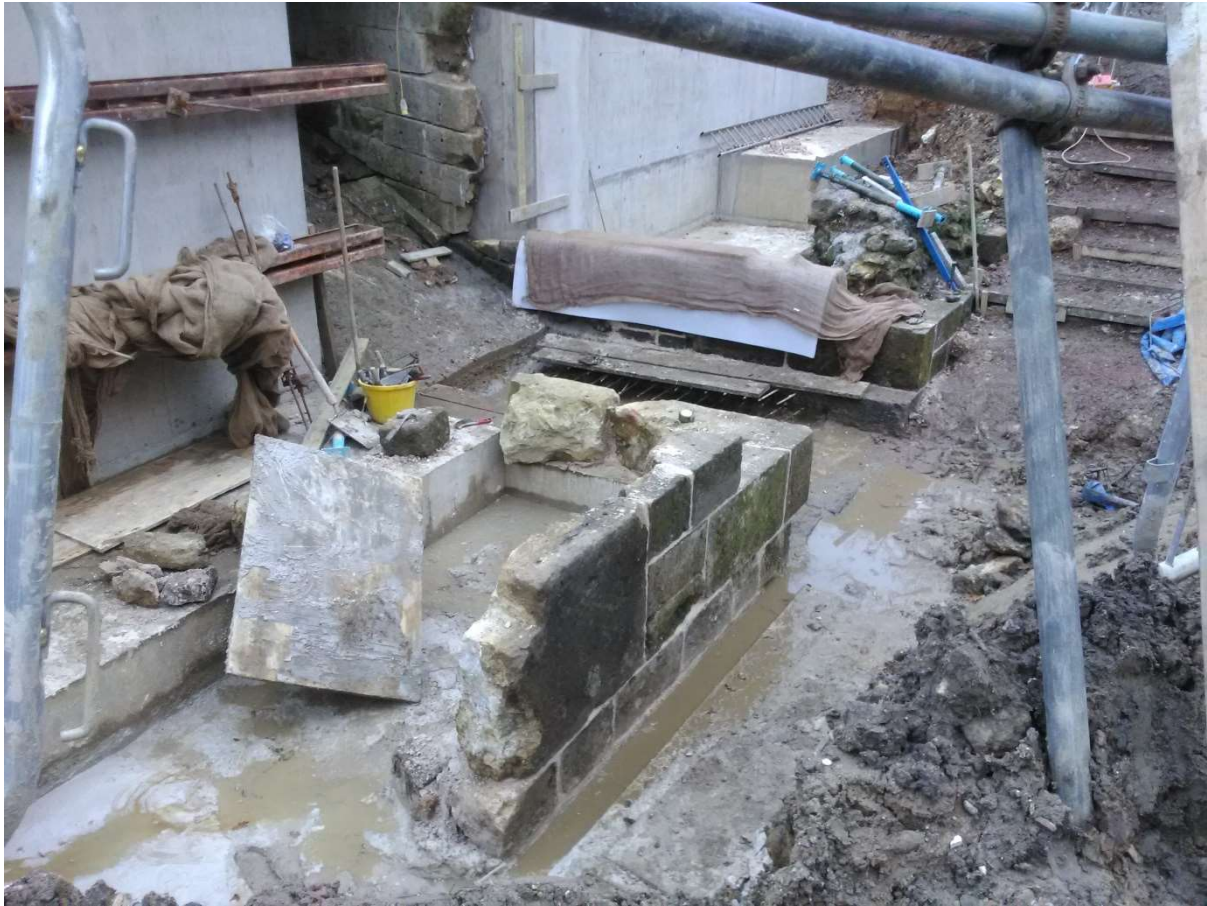
The old stonework begins to rise at the southern end. It will be a slow process as the lime mortar being used takes a long time to 'go off' in cold temperatures. The original mortar was analysed and this is the closest we can achieve today.

The length of hessian towards the top of the photo is protecting the stonework underneath from any potential frost. Above the left-hand end of the hessian concrete now joins the new reinforced concrete (RC) wall to the backing of the barrel arch. Concrete blocks are being used to bridge the gap on the side of the barrel nearer to us.
