Repair Project update-05- (end of January)

The objective of the project is to conserve the archaeology in the northern works and to stabilise and consolidate the southern spillway.

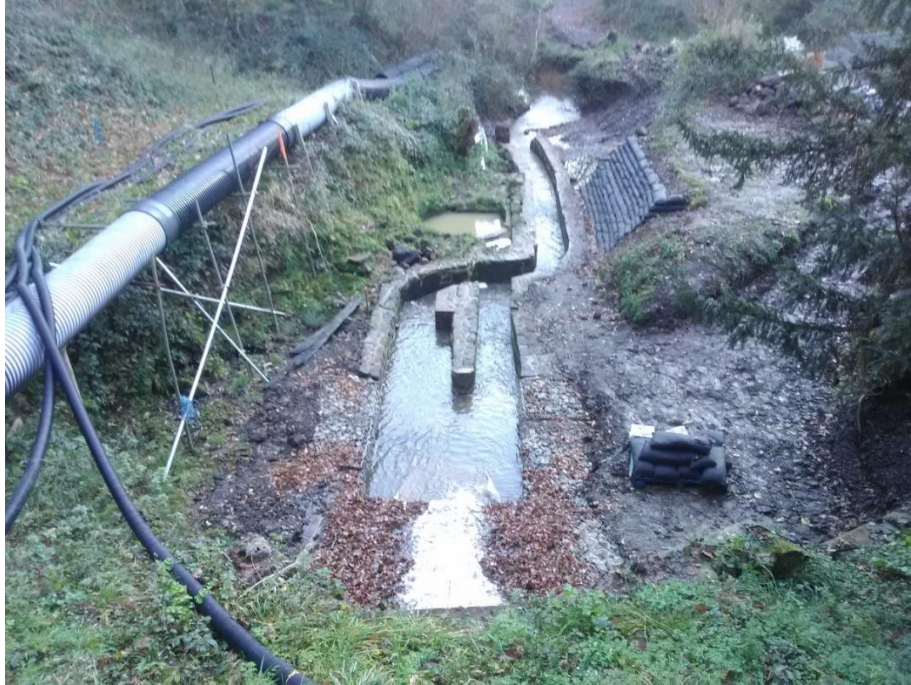
Little work is needed at the northern end except to complete the landscaping. As the budget is very restricted FFPG have been asked to complete the landscaping which will begin as soon as C J Thorne have completed the contract and vacated the site. The work will involve setting out the soil filled sandbags and back filling with slag where necessary. We will need volunteers please!!!

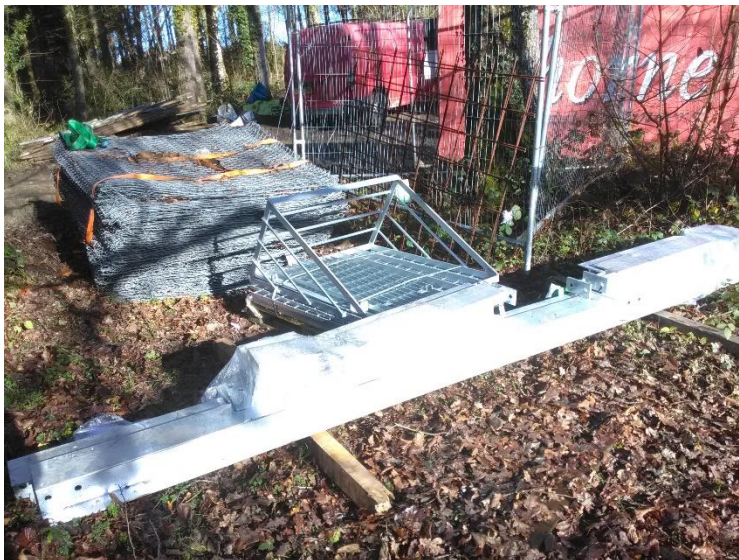
The new access walkway for the penstock controls has arrived and is awaiting installation.

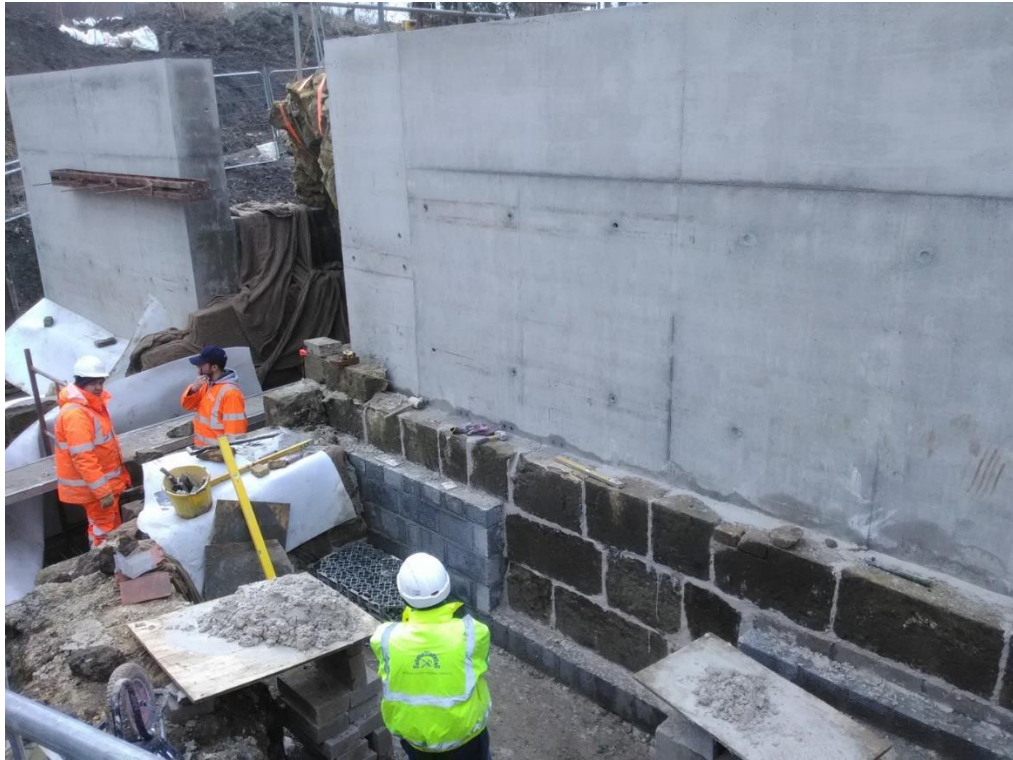
The old stonework begins to rise at the southern end. It will be a slow process as the lime mortar being used takes a long time to 'go off' in cold temperatures. The original mortar was analysed and this is the closest we can achieve today. This base to the main wall will have one more course before it will 'break ground' (when back filled). Some of the stones are only 150mm deep whereas others are up to 600mm deep which need to be cut to a consistent depth and the 'offcut' can be used where a new stone is required.

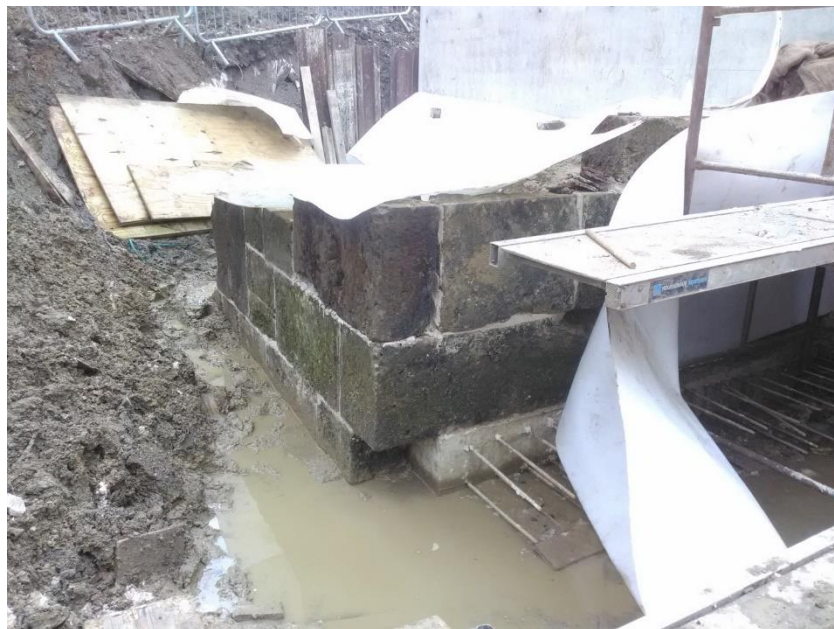
The large darker stone end on to camera (top course) has been missing since Carla and I took on the site 37 years ago. It was found about 5m away buried.
